RICHLAND MIGRANT CENTER LANDING AND STAIR REPAIRS

479 BERNARD AVE
YUBA CITY, CA 95991

- DECK REPAIRS, GUARDRAIL MODIFICATIONS, AND STAIR ALTERATIONS AT ALL UNITS IN BUILDINGS A, B, C, D.

Subject: Yuba City Migrant Farm Worker Housing Center
479 Bernard Drive, Yuba City, CA
Site Visit for Wood Decay Findings at Entry Stair Landings

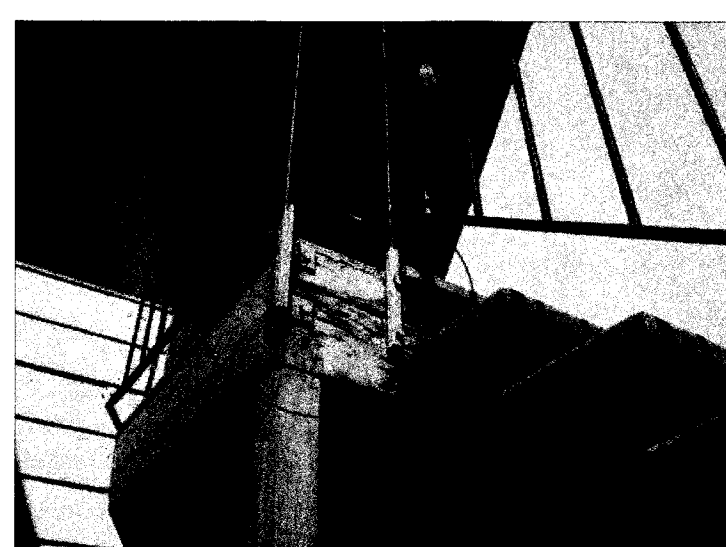
Photo 6: Wood decay at end of outer beam above post connection.

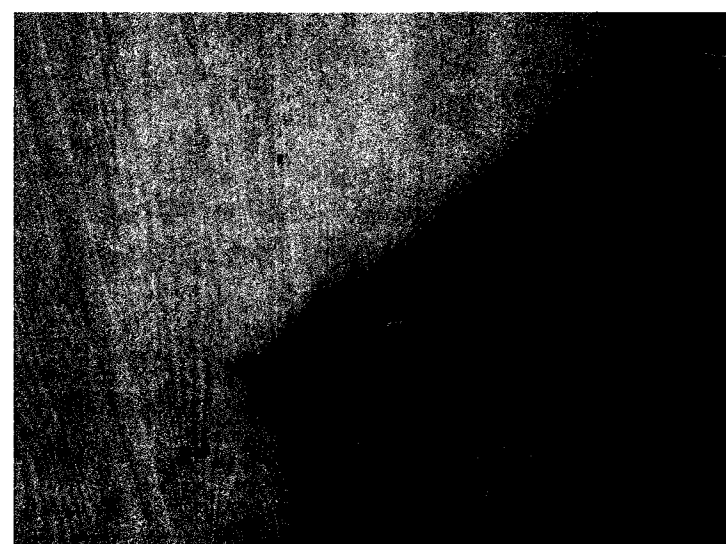
Photo 7: Apparent wood decay behind wall sheathing.

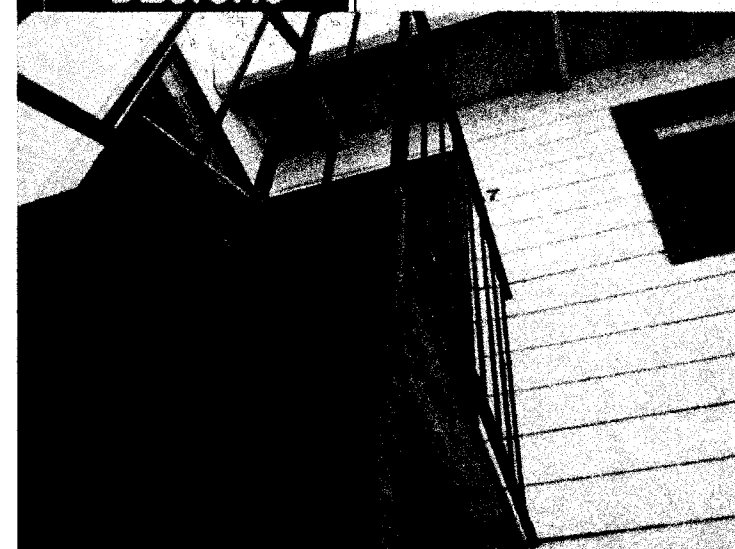
Missing guardrail anchorage bolt at beam at Unit A7.

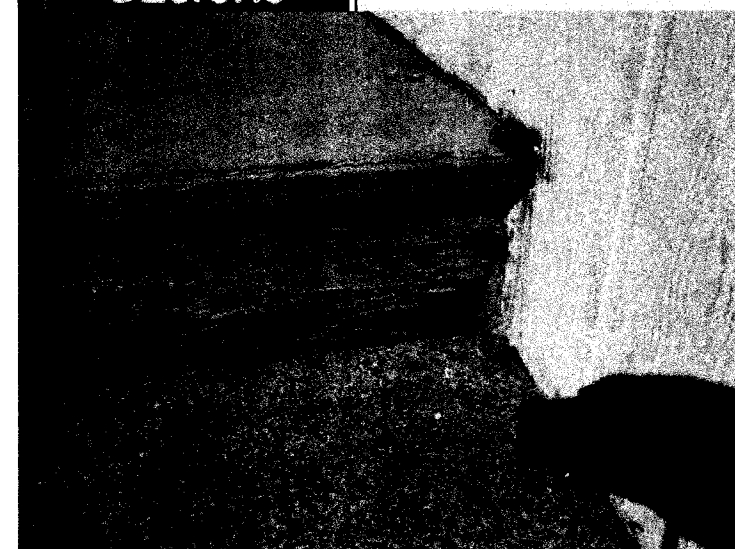
Wood decay noted at stair landing beam end at Unit A3.

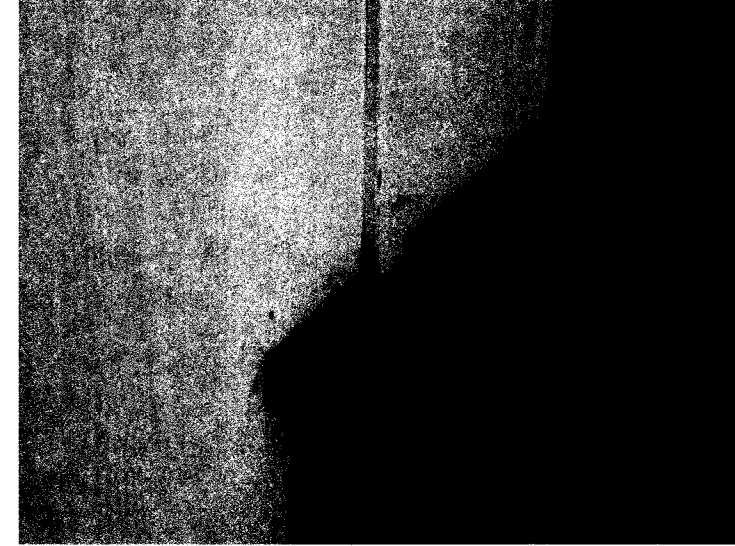
Apparent wood decay behind sheathing at Unit B7. Seam between wall sheathing and landing is not water proof (typical at most stair landings at wall intersections).

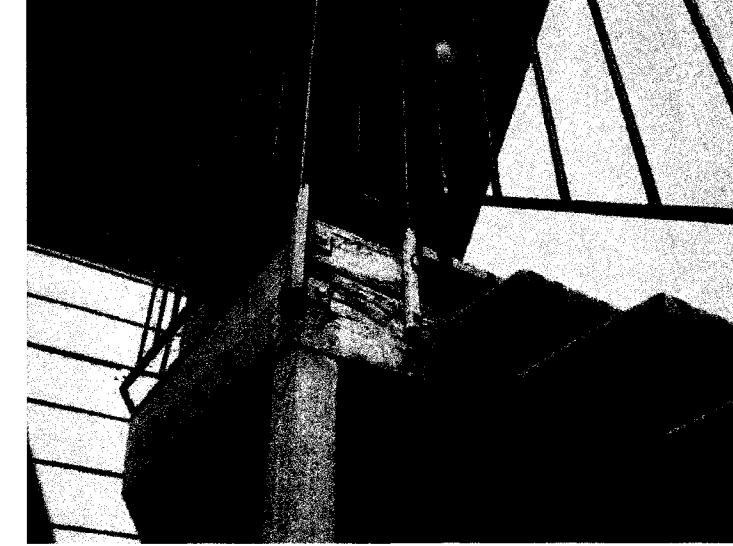
Wood decay noted at stair landing beam end at Unit B3.

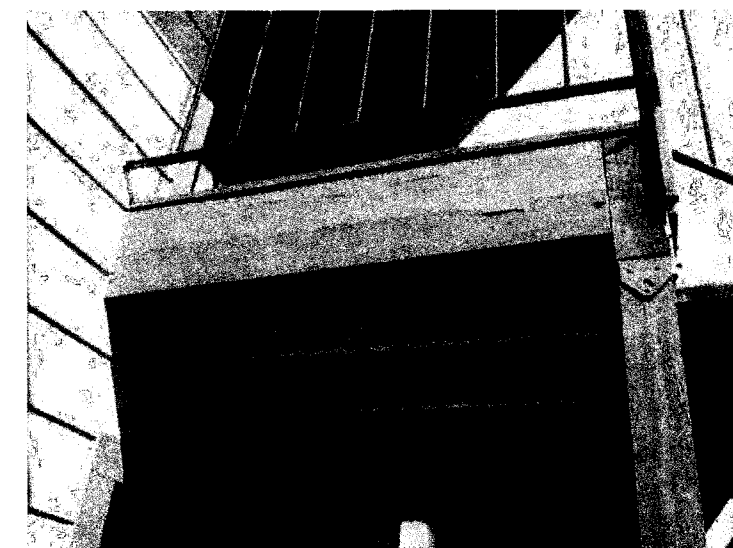
Warped and possibly split outer joist at Unit B3.

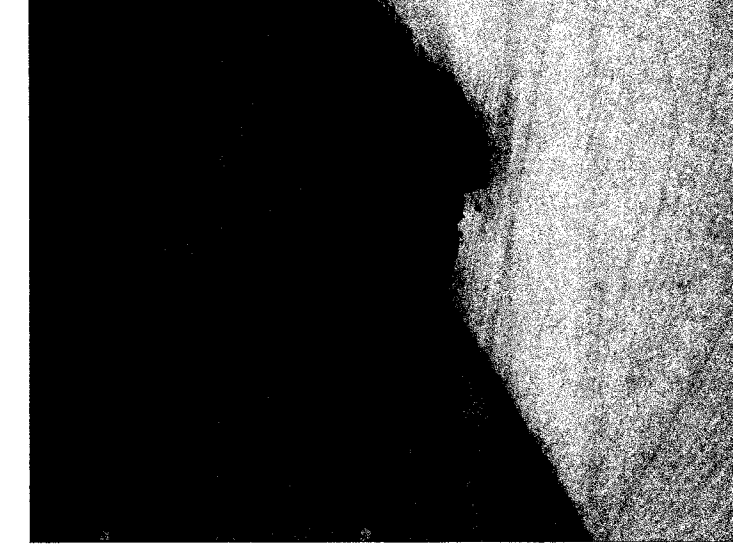
Wood decay noted at stair landing beam end at Unit A11.

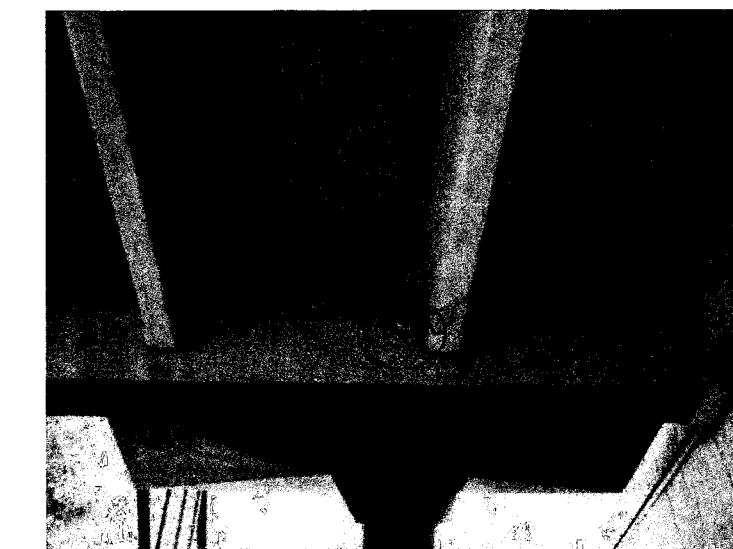
Loose bolt at stair support connection at Unit A9.

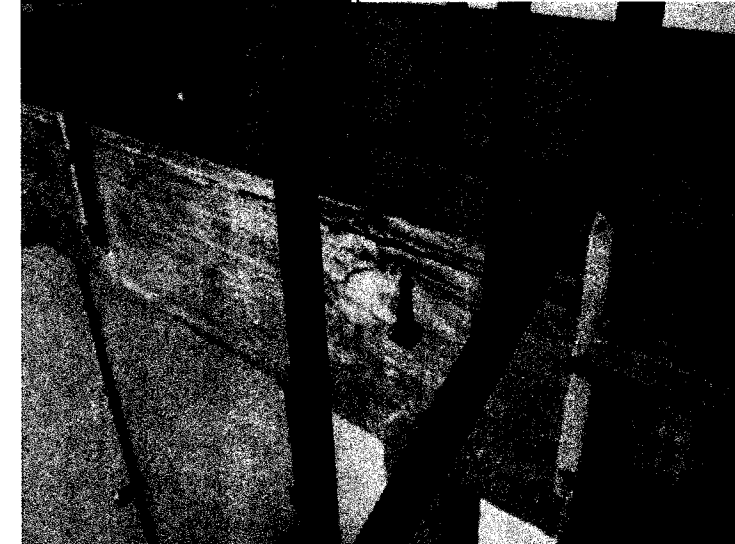
Wood decay at beam above support post at Unit B11. Note weathering and warping of landing sheathing.

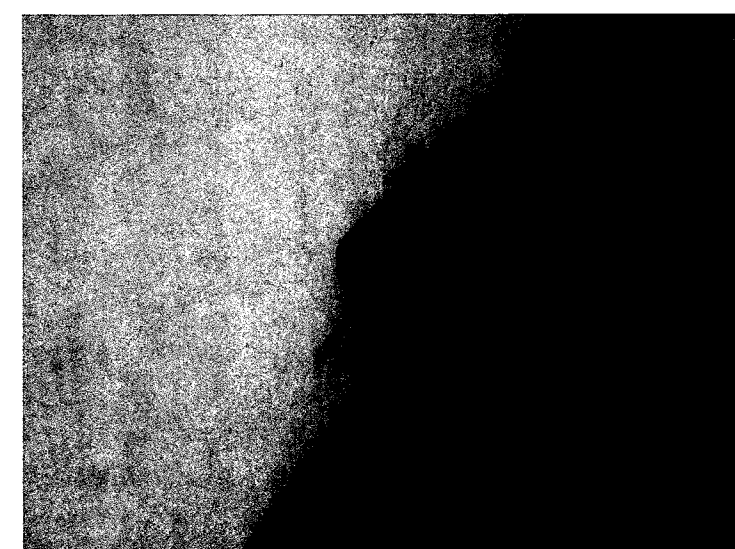
Wood decay noted at stair landing beam end at Unit C1.

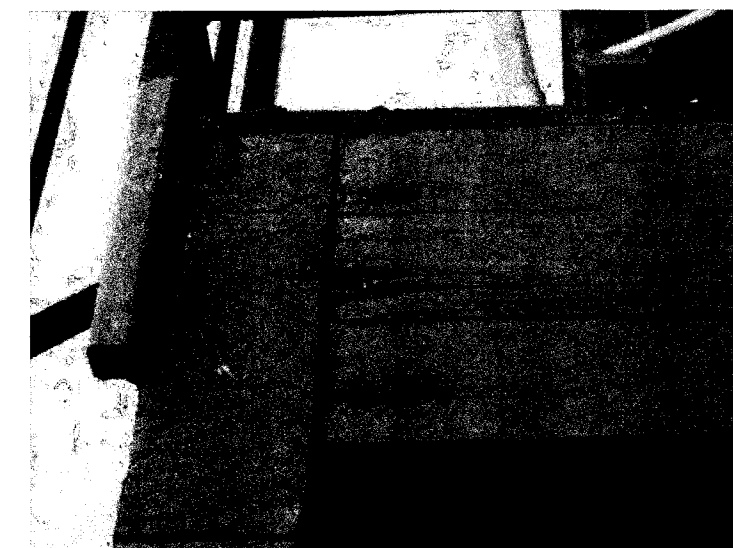
Wood decay in outer joist end at Unit B7.

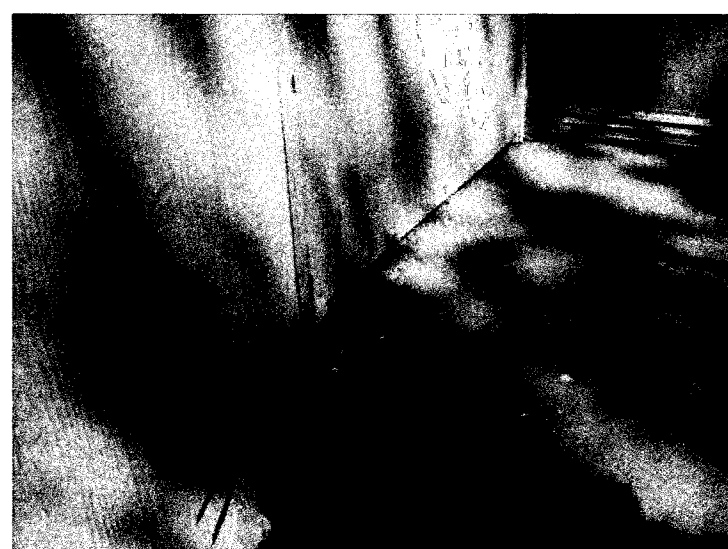
Landing sheathing and waterproofing damaged at Unit D5.

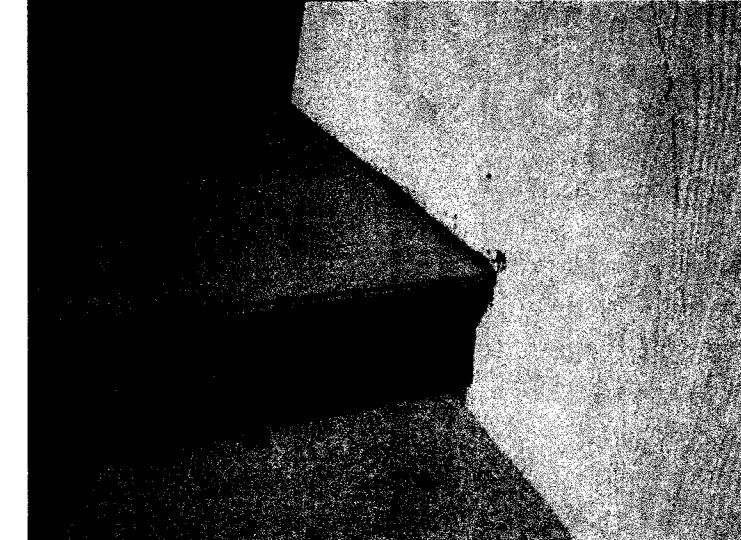
Weathered beam and cracked landing waterproofing material at Unit D1. No wood decay noted at this Unit.

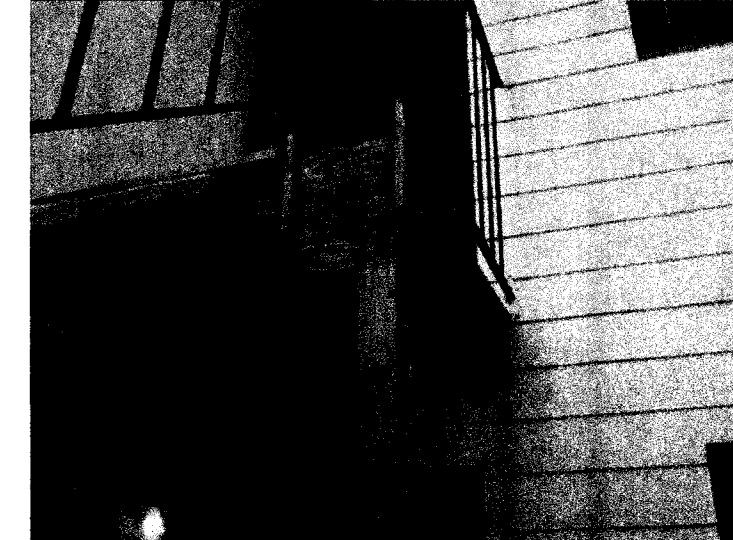
Wood decay noted at stair landing beam end, and at guardrail support location, at Unit C9.

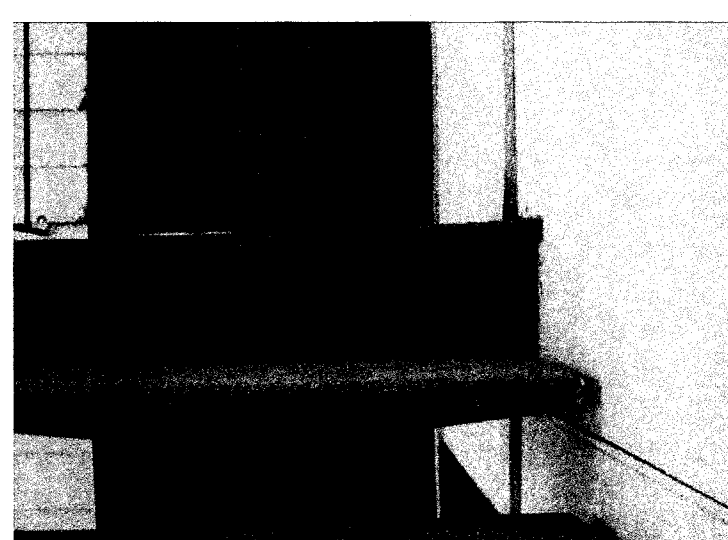
Gap between landing sheathing and beam at Unit D7. Beam is weathered; however, no wood decay was noted.

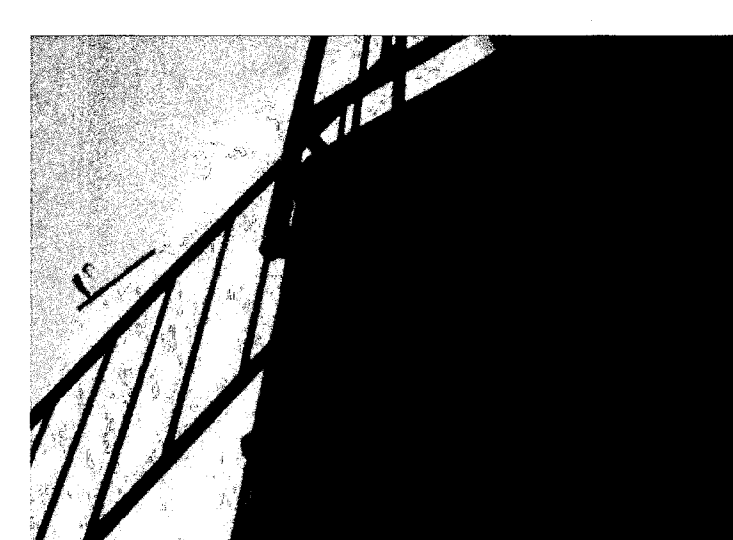
Wood decay noted at outer joist to beam connection at Unit C9.

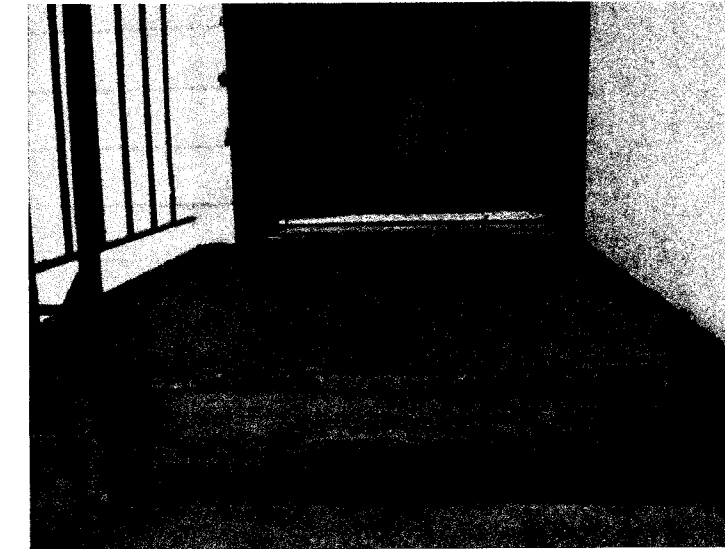
Wood decay noted at stair landing beam end at Unit D9.

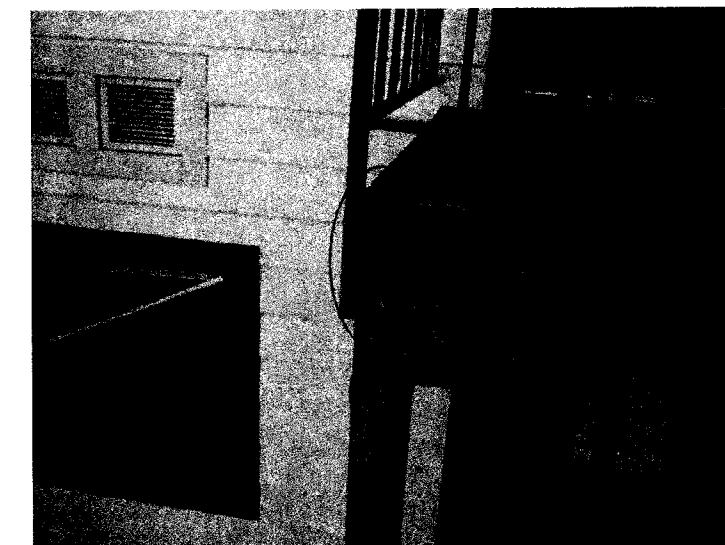
Missing guardrail anchorage bolts at Unit D9.

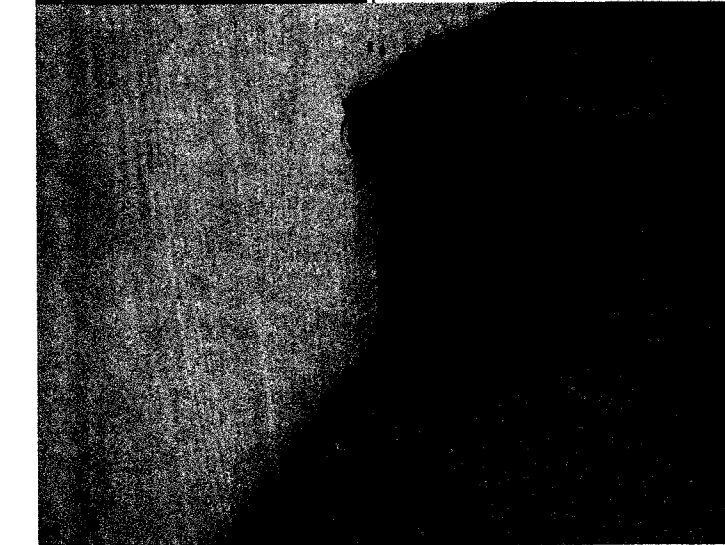
Wood decay noted at stair landing beam end at Unit D11.
