RICHLAND MIGRANT CENTER LANDING AND STAIR REPAIRS

479 BERNARD AVE
YUBA CITY, CA 95991

- DECK REPAIRS, GUARDRAIL MODIFICATIONS, AND STAIR ALTERATIONS AT ALL UNITS IN BUILDINGS A, B, C, D.

Subject: Yuba City Migrant Farm Worker Housing Center
479 Bernard Drive, Yuba City, CA
Site Visit for Wood Decay Findings at Entry Stair Landings

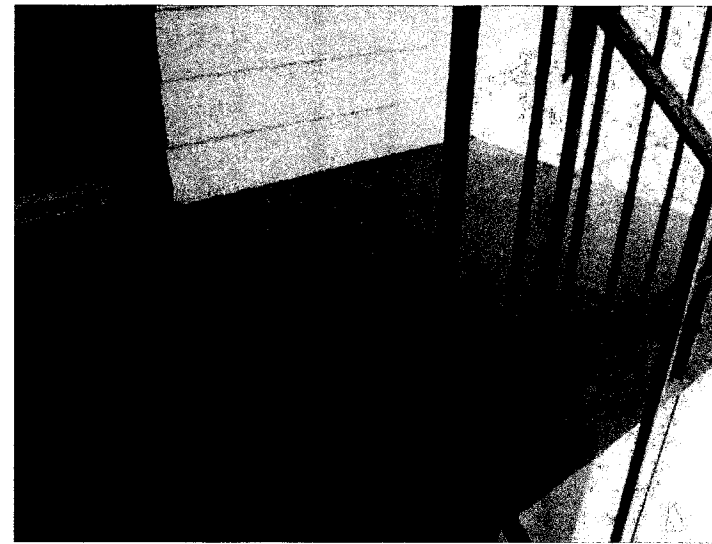
Photo 3: Typical 4'-0" x 10'-0" Stair Landing.
